ENVIRONMENTAL GEOLOGY NOTES

JULY 1976 • NUMBER 76

*Bluff Erosion,
Recession Rates,
and
Volumetric Losses
on the Lake Michigan Shore in Illinois*

Richard C. Berg and Charles Collinson

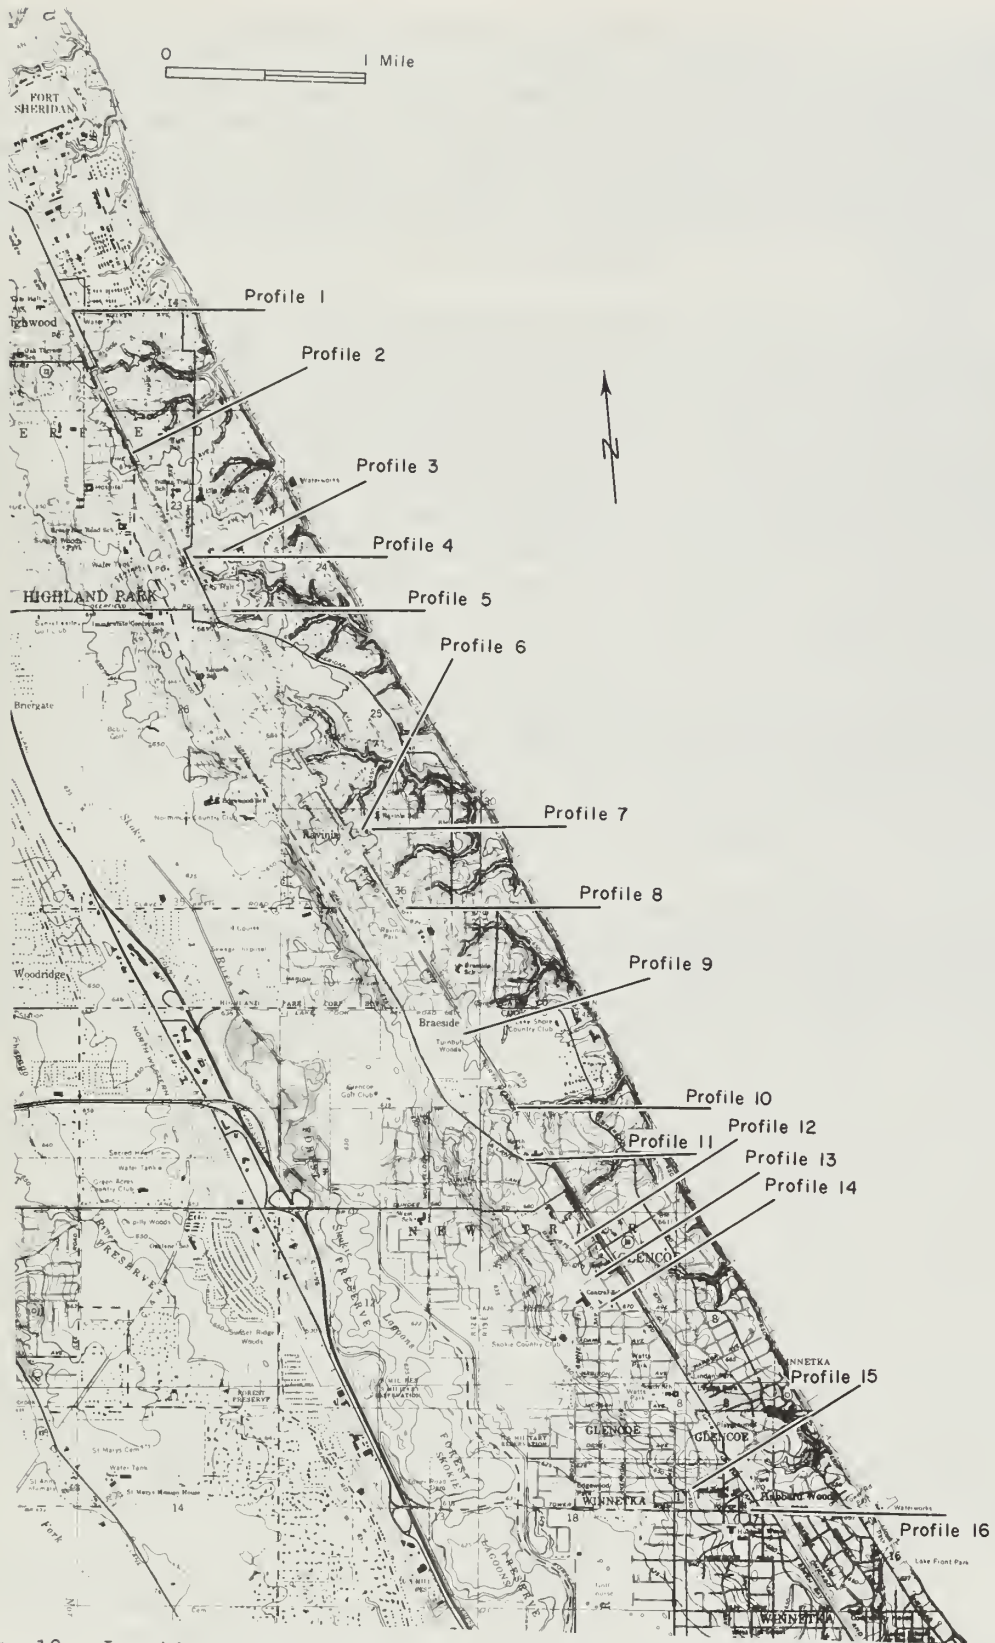
Fig. 10 - Location of profiles used to calculate erosion rates in Highland Park, Glencoe, and Winnetka.

and 1975 and between 1964 and 1975 to determine the area's erosion history. Nine profiles were measured in Highland Park, five in Glencoe, and two in Winnetka. In Highland Park, two profiles showed evidence of significant erosion. At profile 1 (fig. 10), near the Highland Park-Fort Sheridan boundary, recession was caused by the slumping of a single 17-foot block during the early 1970s. At the second site (profile 9) at the southern extremity of Highland Park, approximately 15 feet of recession has occurred since 1964 on a 200-foot reach of shore.
